Unique Project #2: The College of Pathology

By: Ed Beaulieu, Aquascape, Inc.

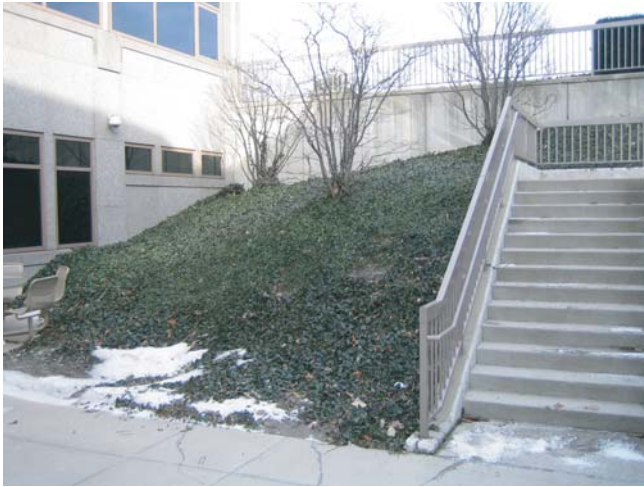
BEFORE

This project was given to us by a local design build firm; they brought us in to assist with this challenging project located on a steep slope within a sunken courtyard. The issue they had been dealing with was the fact that the steep slope was an erosion nightmare and despite being covered in foliage soil was stripped away from the surface during rain events. The soil was clogging the drains in the patio and creating a muddy mess for the maintenance team to clean-up on a routine basis. The designer wanted to provide a sustainable erosion control system and at the same time an aesthetically pleasing waterfall.

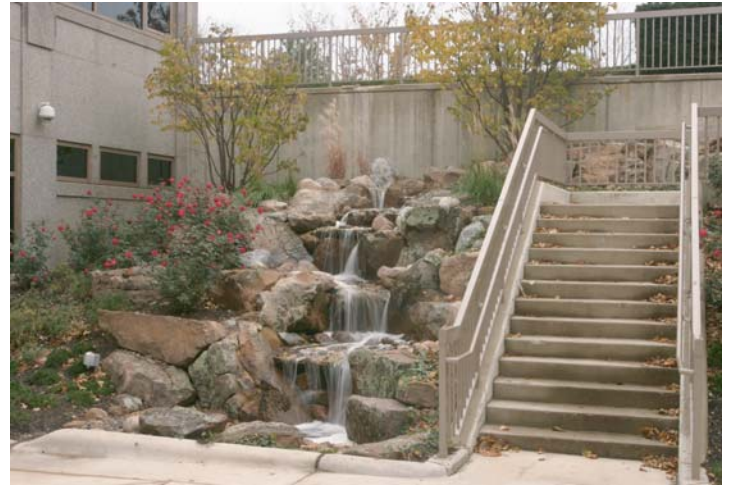
AFTER

A pondless waterfall was the perfect solution and through the process of construction we re-graded the slope and installed large specimen moss rocks to achieve the desired effect.

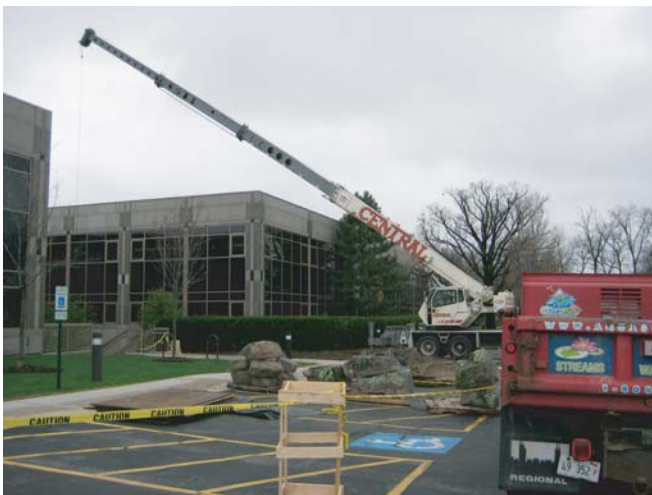
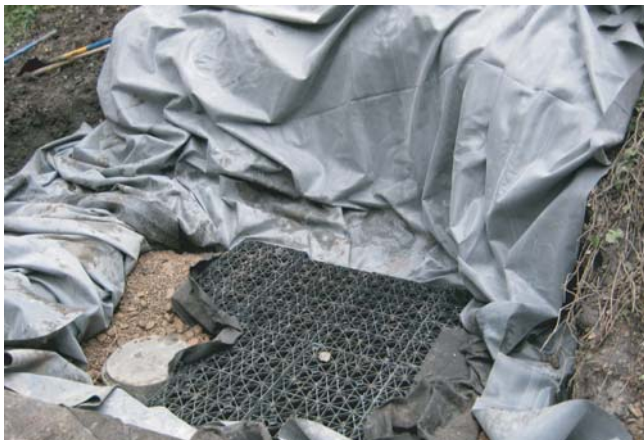
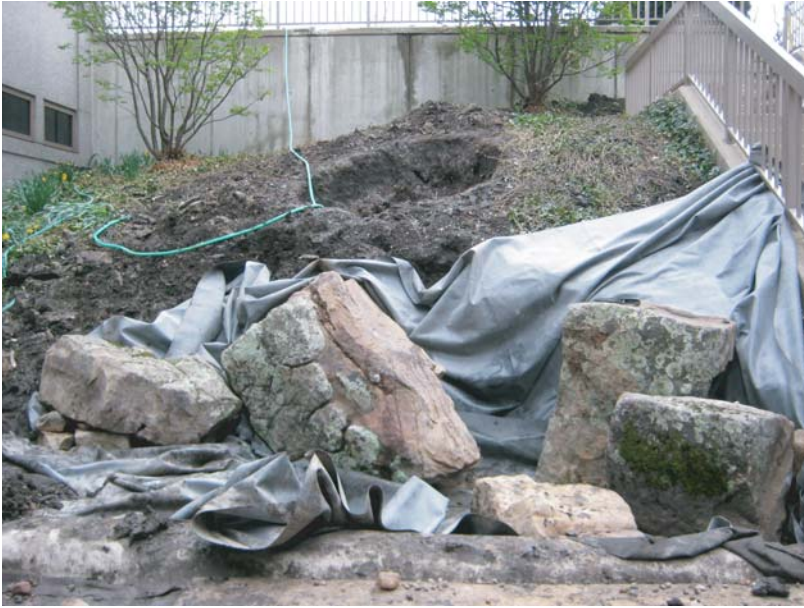
The moss rocks were delivered and staged in the parking lot adjacent to the crane eliminating multiple handling of the materials. Each rock was carefully selected, strapped and lifted into position, the crane operator had steady hands as he maneuvered the large stones between the granite and glass of the building, over the railings and around the trees before the final location of the boulders was reached. It took an average of 20 minutes to set one large stone; smaller stones were set between the large rocks by hand. The smaller stones were delivered using the bobcat bucket which was then dumped along the outside edge of the waterfall within easy reach of our artists.

While we moved up the slope we would not only build the waterfalls but we'd place accent stones designed to terrace the slope and slow down the water during storm events. These accent stones are an important component of any well designed water feature as they help to blend the feature into the adjacent landscape.
