# RainXchange™ System—Pondless® Waterfall

## Grantville, GA

*Installed by Aquascape, Inc. and Certified Aquascape Contractors in April, 2008*

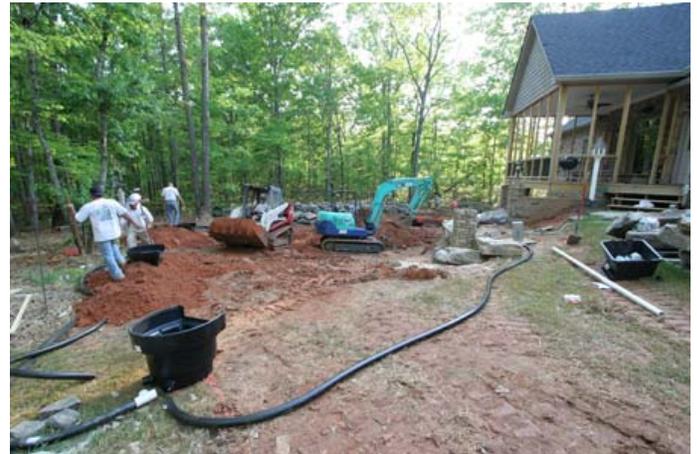
Excavation begins and BioFalls® Filters are placed to mark the start of each of the 3 waterfalls running into the underground basin.

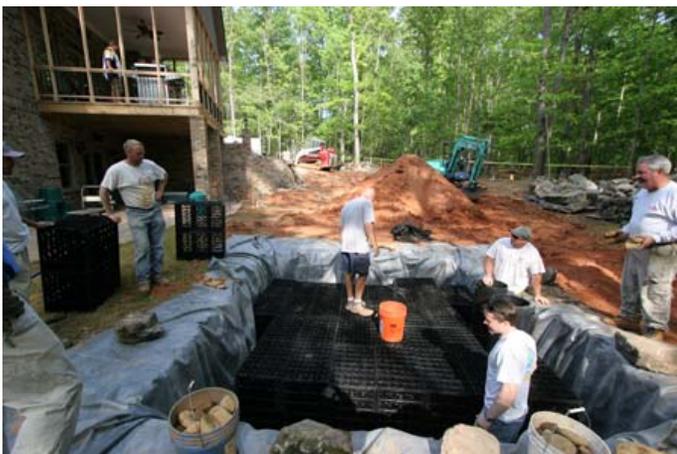
AquaBlox® are set into the storage basin after liner is placed. The 2500 gallon storage area is located at the lower end of the property.

The homeowner's sloping property was an ideal location for a Pondless® Waterfall that would incorporate 3 main waterfalls coming together in one stream leading to a rainwater storage basin. Seventy-eight modular AquaBlox® were set into the excavated rainwater storage basin and three pumps installed to create the 3 main waterfalls. The water feature holds up to 2500 gallons of water in its basin. One downspout from the home feeds directly into the basin, while the second downspout feeds into the top of one of the waterfalls.

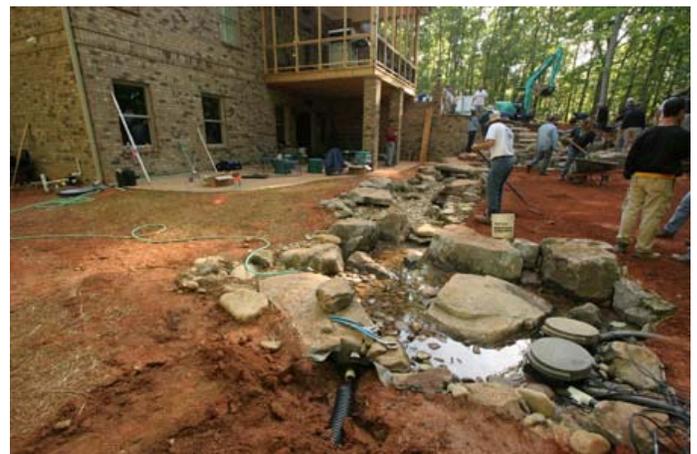
The waterfalls and stream are rocked in and directed toward the underground storage basin, which has also been rocked in.

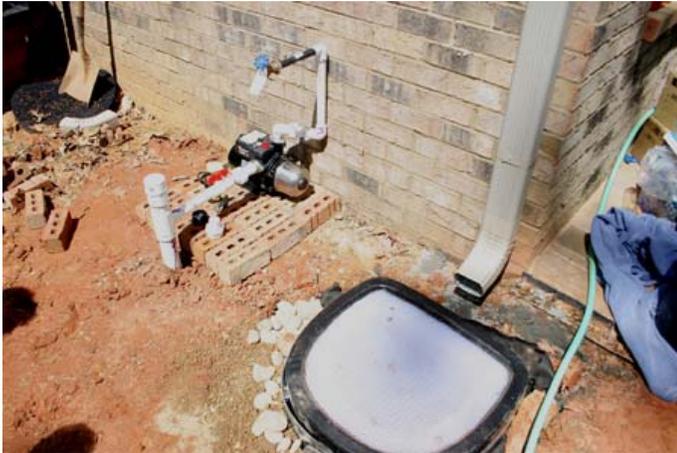
The Downspout Filter is located underneath the gutter and the Booster Pump is ready to hook up to a garden hose for irrigation.

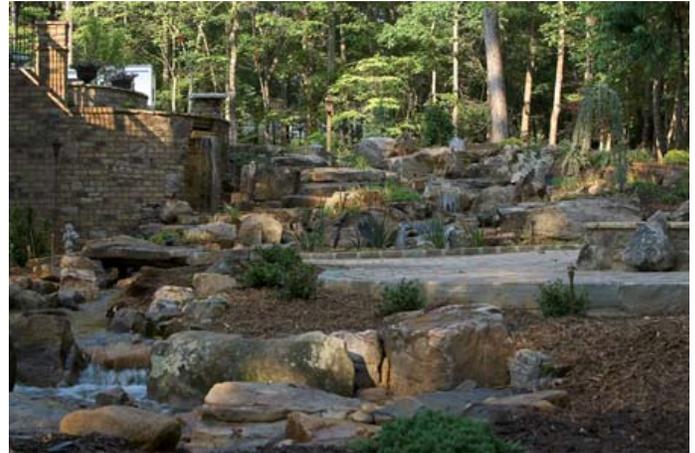
Three main waterfalls merge into one stream at the lower end of the property before flowing into the storage basin.

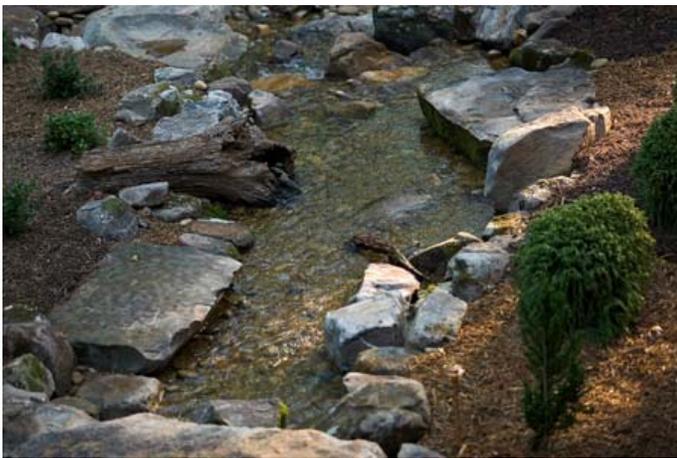
A close-up view of the main stream. Various sized rocks and fallen tree branches are used to naturalize the feature.

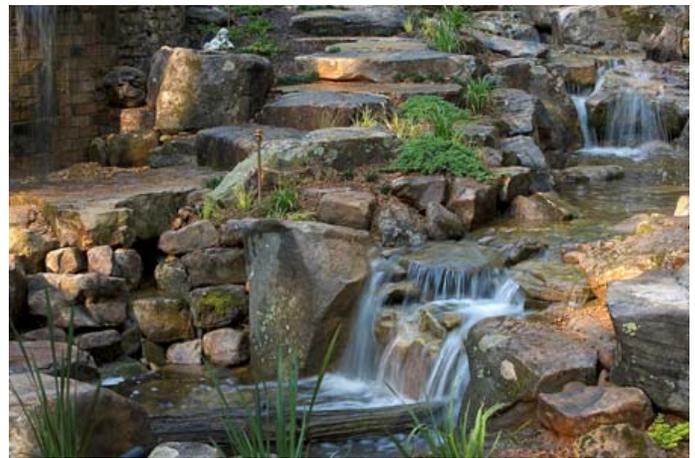
The waterfalls flow directly next to a stone staircase below the main patio area. Note the use of plants for naturalization.

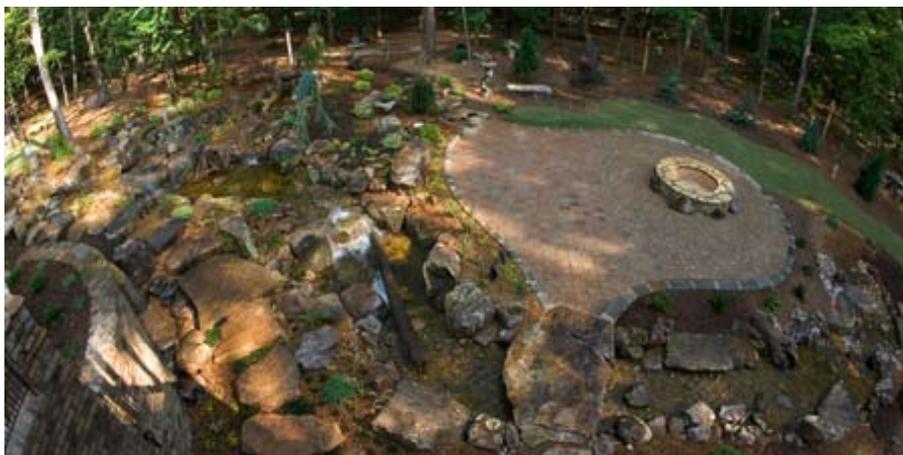
A birds eye view of the lower patio with fire pit. The water feature and rainwater harvesting system appear as though they've always existed in this wooded piece of property. The photo at right shows the waterfalls when viewed from the top.
